**Flood Control Project Maintenance  
Levee Inspections**  
**LMA District Cover Sheet**  
**Spring 2017 Levee Inspection Results**

**Sacramento Maintenance Yard Maintenance Area 0009**

Waterway			Bank	Unit Miles
Unit No. 01 Sacramento River			Left	19.35
	Spring (March - May)	Summer (June - August)	(September - November) Fall	Winter (December - February)
Unit Maintenance Rating (Fall Only)				
Date of Inspection	4/25/2017 - 4/26/2017			
DWR Inspector	Zach Jojola			
Accompanied By	Dave Williams Sacramento Maintenance Yard

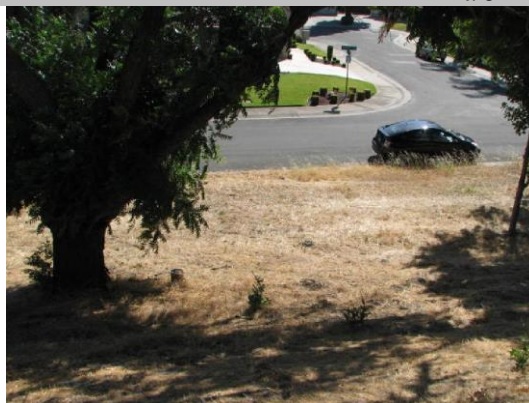
Photo 1 of 1 : UCIP\_SP\_2017\_41067\_6688.jpg

LM Start	6.16	Rating **	M	Issue No.	1794
LM End	6.16	Issue Type +	En	Location *	WS
Category	Supplemental			GPS Latitude/Longitude	
				Start	End
Item	DWR UCIP Field Study			38.481270 °	38.481270 °
				-121.545630 °	-121.545630 °
DWR ID					
Comment Code					
Inspector Comment					
FS_ID:41067 DS_ID:17379 EP_NO: N/A Repair Type: Non-Urgent Crossing Status: Indicator Found UCIP Comments: remains of a cut off telephone pole 50-feet downstream from this location may be good indicator of abandoned pipe location. FIELD_STRUCT_DESC: 6-inch pipe through the levee approximately 17-feet below the crown. Constructed with 1-cm cut-off wall and pump and check valve on river side. Pipe has been plugged and abandoned in place 10/31/89. Originally included in O+M manual (1955). FS Date: 6/21/2012 3:50:00 PM

Sawed off power pole at LS toe 50-feet Downstream from pipe location may be good indicator of Abandoned pipe location.

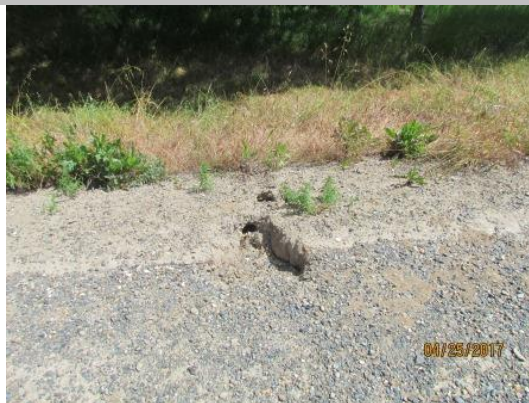
Photo 1 of 1 : SP\_2017\_MA0009\_201\_285\_20170426\_00506.jpg

LM Start	6.20	Rating **	M	Issue No.	285
LM End	6.20	Issue Type +	Ma	Location *	LS
Category	Earthen Levee			GPS Latitude/Longitude	
				Start	End
Item	Animal Control			38.480666 °	38.480666 °
				-121.545190 °	-121.545190 °
DWR ID	DWR_MA0009_01_s_2017_285				
Comment Code					
A3 : No rodents visible, but rodent burrows visible; need to backfill and compact or grout burrows.					
Inspector Comment					
Rodent hole on landside levee shoulder.

View of burrow hole on landside shoulder. Spring 2017.

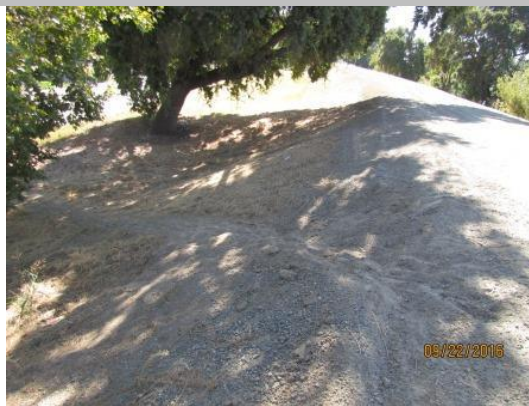
Photo 1 of 2 : SP\_2017\_MA0009\_201\_337\_20170320\_00257.jpg

LM Start	6.24	Rating **	M	Issue No.	337
LM End	6.24	Issue Type +	Ma	Location *	LS
Category	Earthen Levee			GPS Latitude/Longitude	
				Start	End
Item	Slope Stability			38.480209 °	38.480209 °
				-121.544893 °	-121.544893 °
DWR ID	DWR_MA0009_01_f_2015_337				
Comment Code					
S2 : Repair the levee slope damaged by foot traffic and prevent access where possible.					
Inspector Comment

View of footpath that causes slope stability on LS of the levee. Fall 2016.

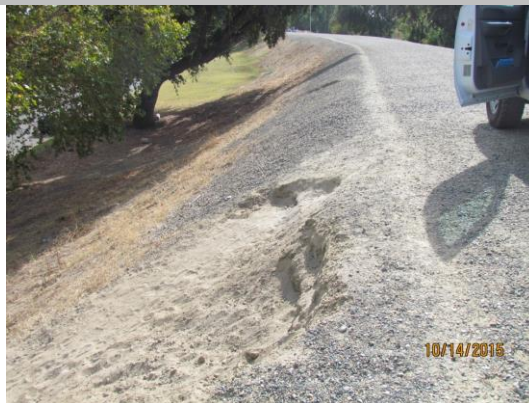
Photo 2 of 2 : SP\_2017\_MA0009\_201\_337\_20170320\_00258.jpg

View of the slope stability caused by foot traffic on the landward side of the levee looking downstream. Fall 2015.

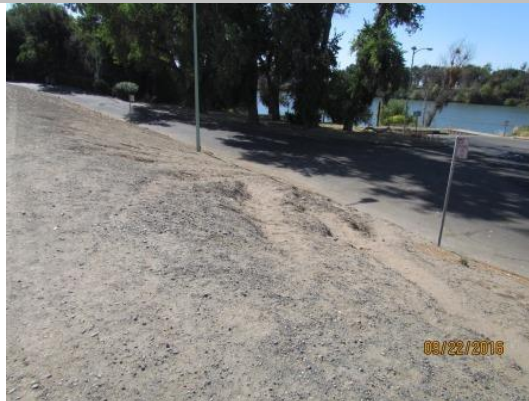
Photo 1 of 2 : SP\_2017\_MA0009\_201\_375\_20170320\_00288.jpg

LM Start	6.37	Rating **	M	Issue No.	375
LM End	6.37	Issue Type +	Ma	Location *	WS
Category	Earthen Levee			GPS Latitude/Longitude	
				Start	End
Item	Slope Stability			38.478698 °	38.478698 °
				-121.543333 °	-121.543333 °
DWR ID	DWR_MA0009_01_s_2016_375				
Comment Code					
S3 : Repair the levee slope damaged by vehicle traffic and prevent access where possible.					
Inspector Comment

View of slope stability on WS of the levee. Fall 2016.

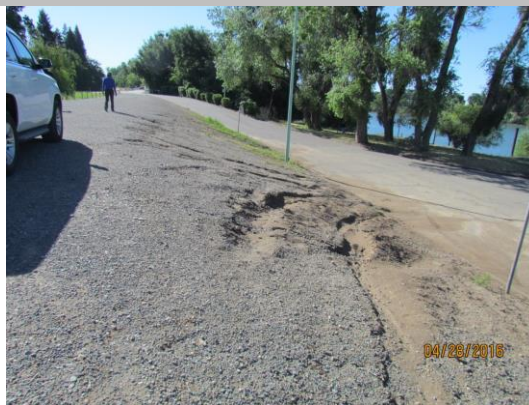
Photo 2 of 2 : SP\_2017\_MA0009\_201\_375\_20170320\_00289.jpg

View of the slope stability on the waterward side of the levee looking downstream. Spring 2016.

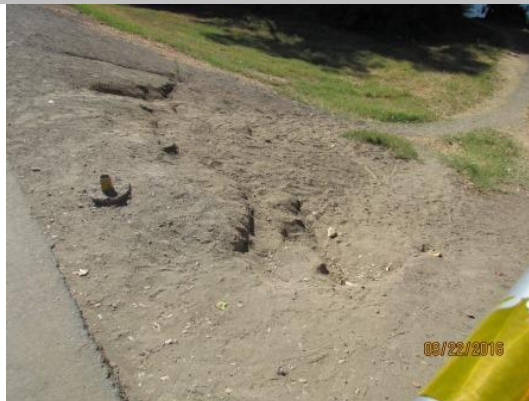
Photo 1 of 3 : SP\_2017\_MA0009\_201\_339\_20170320\_00259.jpg

LM Start	6.43	Rating **	M	Issue No.	339
LM End	6.43	Issue Type +	Ma	Location *	WS
Category	Earthen Levee			GPS Latitude/Longitude	
				Start	End
Item	Slope Stability			38.478082 °	38.478082 °
				-121.542589 °	-121.542589 °
DWR ID	DWR_MA0009_01_f_2015_339				
Comment Code					
S2 : Repair the levee slope damaged by foot traffic and prevent access where possible.					
Inspector Comment

An updated view of slope stability site. WS slope of the levee. Fall 2016.

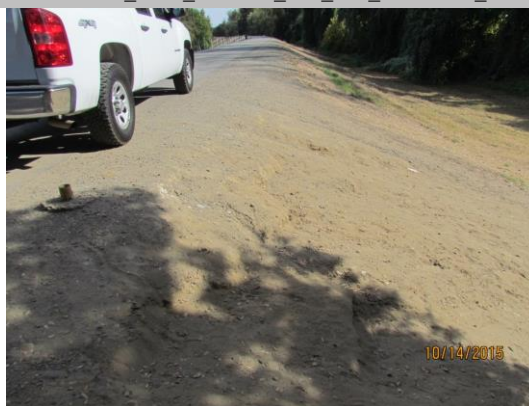
Photo 2 of 3 : SP\_2017\_MA0009\_201\_339\_20170320\_00260.jpg

Perspective view of the slope stability on the waterward side of the levee looking downstream. Fall 2015.

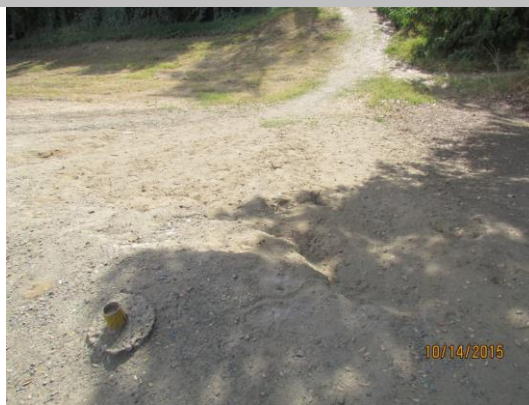
Photo 3 of 3 : SP\_2017\_MA0009\_201\_339\_20170320\_00261.jpg

Slope stability is caused by foot traffic. Fall 2015.

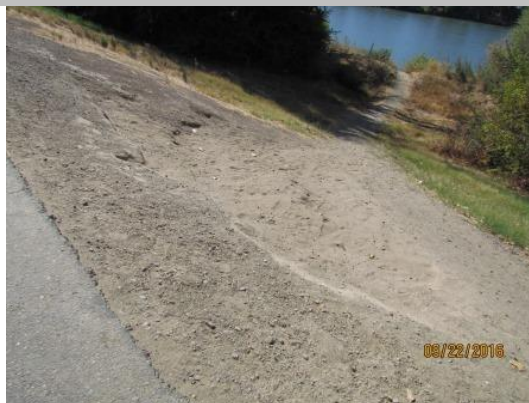
Photo 1 of 3 : SP\_2017\_MA0009\_201\_301\_20170320\_00223.jpg

LM Start	6.53	Rating **	M	Issue No.	301
LM End	6.53	Issue Type +	Ma	Location *	WS
Category	Earthen Levee			GPS Latitude/Longitude	
				Start	End
Item	Slope Stability			38.477116 °	38.477116 °
				-121.541253 °	-121.541253 °
DWR ID	DWR_MA0009_01_s_2015_301				
Comment Code					
S2 : Repair the levee slope damaged by foot traffic and prevent access where possible.					
Inspector Comment

An updated view of slope stability site. Waterward side of the levee. Fall 2016.

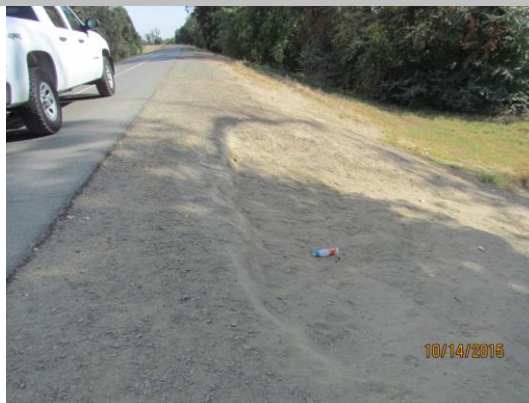
Photo 2 of 3 : SP\_2017\_MA0009\_201\_301\_20170320\_00224.jpg

Perspective view of the slope stability on the waterward side of the levee looking downstream. Fall 2015.

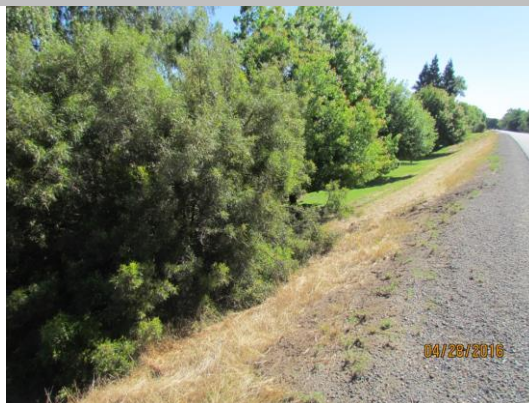
Photo 1 of 1 : SP\_2017\_MA0009\_201\_377\_20170320\_00290.jpg

LM Start	6.96	Rating **	M	Issue No.	377
LM End	6.96	Issue Type +	Ma	Location *	LS
Category	Earthen Levee			GPS Latitude/Longitude	
				Start	End
Item	Trim / Thin Trees			38.474836 °	38.474836 °
				-121.534175 °	-121.534175 °
DWR ID	DWR_MA0009_01_s _ 2016_377				
Comment Code					
T3 : Trim and thin trees to allow visibility of the ground and room to flood fight.					
Inspector Comment

View of the trees on the landward side of the levee looking downstream. Spring 2016.

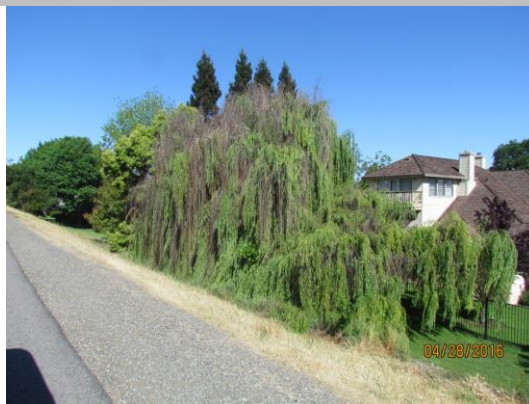
Photo 1 of 1 : SP\_2017\_MA0009\_201\_304\_20170320\_00227.jpg

LM Start	7.21	Rating **	U	Issue No.	304
LM End	7.21	Issue Type +	Ma	Location *	LS
Category	Earthen Levee			GPS Latitude/Longitude	
				Start	End
Item	Trim / Thin Trees			38.474851 °	38.474851 °
				-121.529516 °	-121.529516 °
DWR ID	DWR_MA0009_01_s _ 2014_304				
Comment Code					
T1 : Trim trees to at least five feet above ground level.					
Inspector Comment

View of the willow tree on the landward side of the levee looking upstream. Spring 2016.

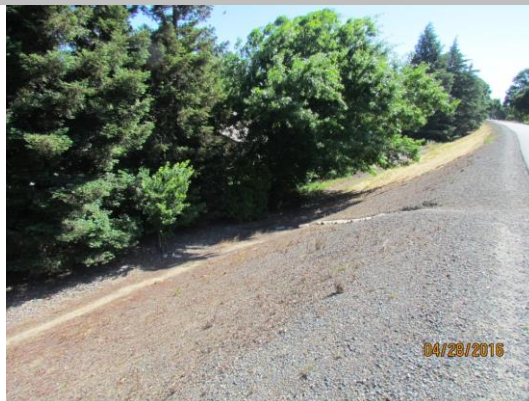
Photo 1 of 1 : SP\_2017\_MA0009\_201\_158\_20170320\_00119.jpg

LM Start	7.25	Rating **	M	Issue No.	158
LM End	7.25	Issue Type +	En	Location *	LS
Category	Earthen Levee			GPS Latitude/Longitude	
				Start	End
Item	Vegetation			38.474861 °	38.474861 °
				-121.528804 °	-121.528804 °
DWR ID	DWR_MA0009_01_s _ 2012_158				
Comment Code					
V6 : Landscaping					
Inspector Comment

View of the landscaping on the landward side of the levee looking downstream. Landscape is borderline at easement of toe. Spring 2016.

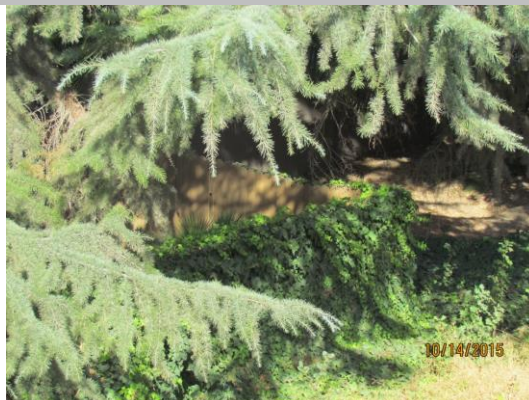
Photo 1 of 2 : SP\_2017\_MA0009\_201\_159\_20170320\_00120.jpg

LM Start	7.30	Rating **	U	Issue No.	159
LM End	7.32	Issue Type +	En	Location *	LS
Category	Earthen Levee			GPS Latitude/Longitude	
				Start	End
Item	Encroachments			38.474916 °	38.474942 °
				-121.527760 °	-121.527482 °
DWR ID	DWR_MA0009_01_s _ 2012_159				
Comment Code					
FE : Fence					
Inspector Comment

The solid fence is located in the trees on the landward side of the levee. Fall 2015.

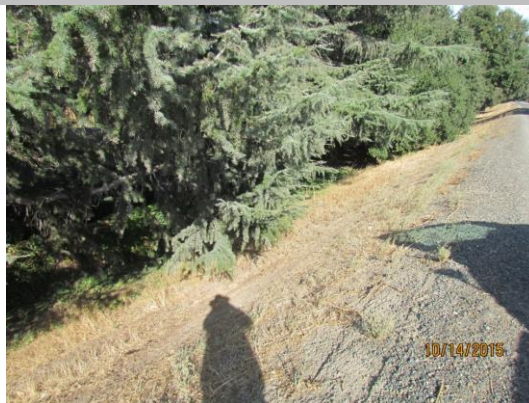
Photo 2 of 2 : SP\_2017\_MA0009\_201\_159\_20170320\_00121.jpg

View of the trees on the landward side of the levee looking downstream.  
Trees need to be trimmed. Fall 2015.

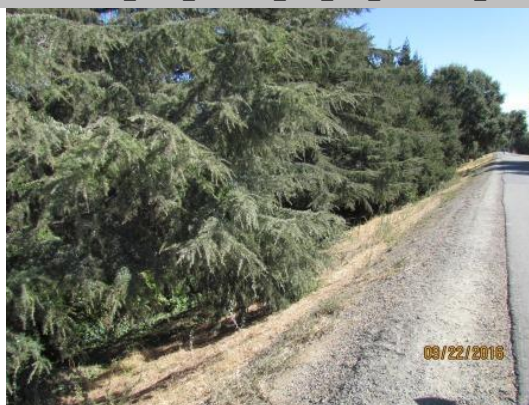
Photo 1 of 1 : SP\_2017\_MA0009\_201\_251\_20170320\_00195.jpg

LM Start	7.31	Rating **	M	Issue No.	251
LM End	7.33	Issue Type +	Ma	Location *	LS
Category	Earthen Levee			GPS Latitude/Longitude	
				Start	End
Item	Trim / Thin Trees			38.474919 °	38.474953 °
				-121.527692 °	-121.527183 °
DWR ID	DWR_MA0009_01_f_2016_251				
Comment Code					
T1 : Trim trees to at least five feet above ground level.					
Inspector Comment

View of the site where tree trimming is needed on LS slope of the levee.  
Fall 2016.

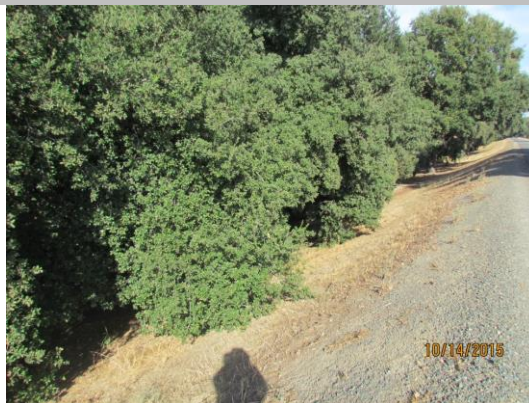
Photo 1 of 1 : SP\_2017\_MA0009\_201\_342\_20170320\_00263.jpg

LM Start	7.33	Rating **	M	Issue No.	342
LM End	7.33	Issue Type +	Ma	Location *	LS
Category	Earthen Levee			GPS Latitude/Longitude	
				Start	End
Item	Trim / Thin Trees			38.474954 °	38.474954 °
				-121.527276 °	-121.527276 °
DWR ID	DWR_MA0009_01_f_2015_342				
Comment Code					
T1 : Trim trees to at least five feet above ground level.					
Inspector Comment					
Tree branches need to be trimmed up at least 5 feet.

View of the trees on the landward side of the levee looking downstream. Fall 2015.

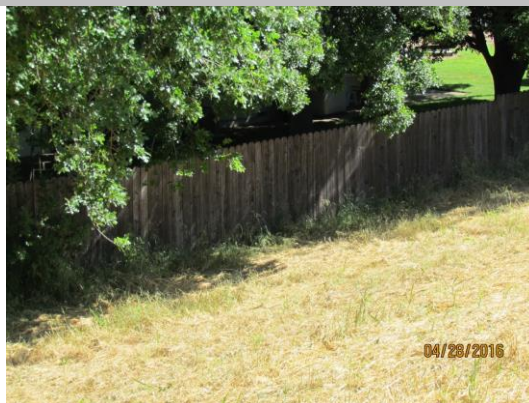
Photo 1 of 2 : SP\_2017\_MA0009\_201\_162\_20170320\_00124.jpg

LM Start	7.44	Rating **	U	Issue No.	162
LM End	7.44	Issue Type +	En	Location *	LS
Category	Earthen Levee			GPS Latitude/Longitude	
				Start	End
Item	Encroachments			38.475156 °	38.475156 °
				-121.525212 °	-121.525212 °
DWR ID	DWR_MA0009_01_s_2012_162				
Comment Code					
FE : Fence					
Inspector Comment

A wooden fence is near the toe of the levee. Spring 2016.

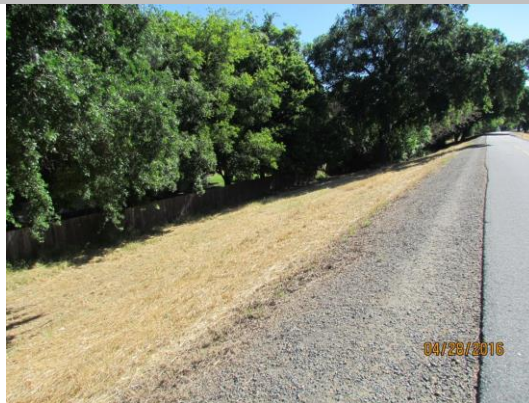
Photo 2 of 2 : SP\_2017\_MA0009\_201\_162\_20170320\_00125.jpg

Perspective view of the wooden fence on the landward side of the levee looking downstream. Spring 2016.

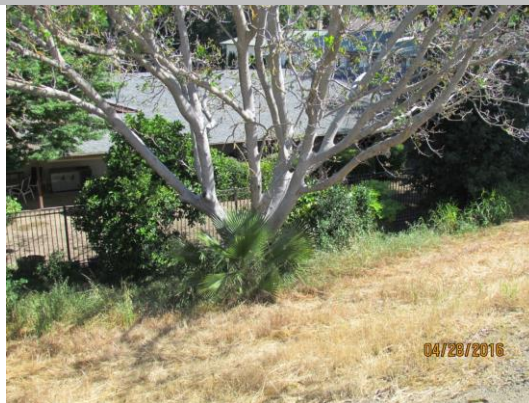
Photo 1 of 1 : SP\_2017\_MA0009\_201\_163\_20170320\_00126.jpg

LM Start	7.48	Rating **	M	Issue No.	163
LM End	7.49	Issue Type +	En	Location *	LS
Category	Earthen Levee			GPS Latitude/Longitude	
				Start	End
Item	Vegetation			38.475227 °	38.475249 °
				-121.524477 °	-121.524312 °
DWR ID	DWR_MA0009_01_s_2012_163				
Comment Code					
V6 : Landscaping					
Inspector Comment

View of the trees and shrub at the toe of the levee. Spring 2016.

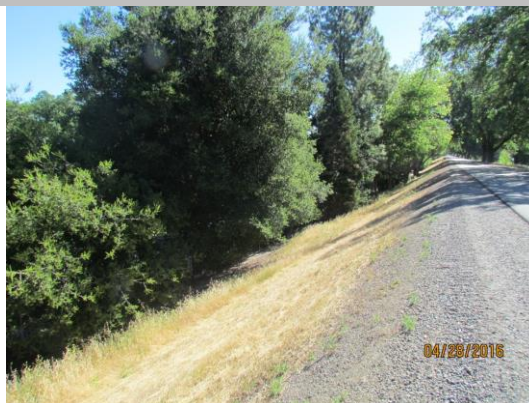
Photo 1 of 2 : SP\_2017\_MA0009\_201\_164\_20170320\_00127.jpg

LM Start	7.51	Rating **	M	Issue No.	164
LM End	7.61	Issue Type +	En	Location *	LS
Category	Earthen Levee			GPS Latitude/Longitude	
				Start	End
Item	Vegetation			38.475270 °	38.475360 °
				-121.524036 °	-121.522178 °
DWR ID	DWR_MA0009_01_s_2012_164				
Comment Code					
V6 : Landscaping					
Inspector Comment

View of the trees along the toe of the levee on the landward side looking downstream. Spring 2016.

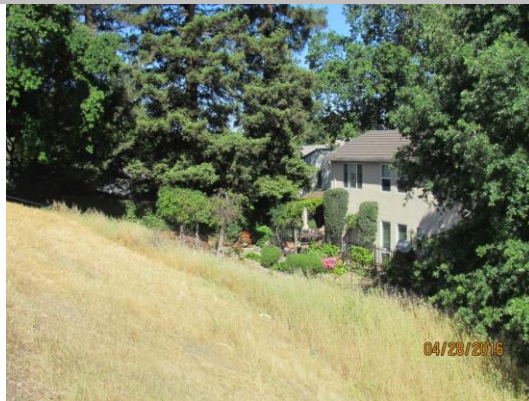
Photo 2 of 2 : SP\_2017\_MA0009\_201\_164\_20170320\_00128.jpg

View of the landscaping and fence at the toe of the levee on the landward side looking upstream. Spring 2016.

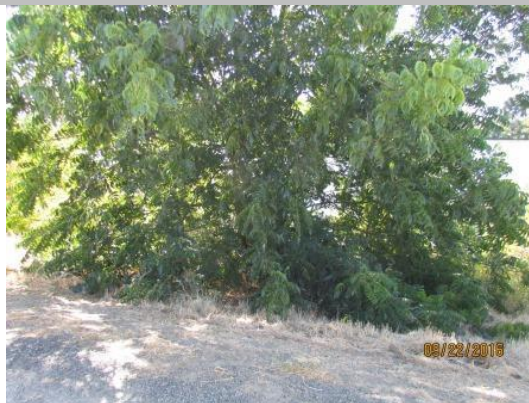
Photo 1 of 1 : SP\_2017\_MA0009\_201\_252\_20170320\_00196.jpg

LM Start	8.05	Rating **	M	Issue No.	252
LM End	8.05	Issue Type +	Ma	Location *	WS
Category	Earthen Levee			GPS Latitude/Longitude	
				Start	End
Item	Trim / Thin Trees			38.475340 °	38.475340 °
				-121.514076 °	-121.514076 °
DWR ID	DWR_MA0009_01_f_2016_252				
Comment Code					
T1 : Trim trees to at least five feet above ground level.					
Inspector Comment

Tree trimming needed at WS slope of the levee. Fall 2016.

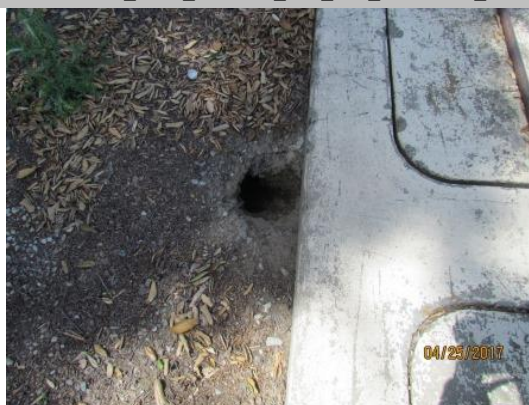
Photo 1 of 1 : SP\_2017\_MA0009\_201\_290\_20170426\_00507.jpg

LM Start	8.60	Rating **	U	Issue No.	290
LM End	8.60	Issue Type +	Ma	Location *	LS
Category	Earthen Levee			GPS Latitude/Longitude	
				Start	End
Item	Animal Control			38.471886 °	38.471886 °
				-121.504999 °	-121.504999 °
DWR ID	DWR_MA0009_01_s_2017_290				
Comment Code					
A3 : No rodents visible, but rodent burrows visible; need to backfill and compact or grout burrows.					
Inspector Comment					
Deep rodent hole within landside shoulder.

View of rodent hole on landside shoulder. Spring 2017.

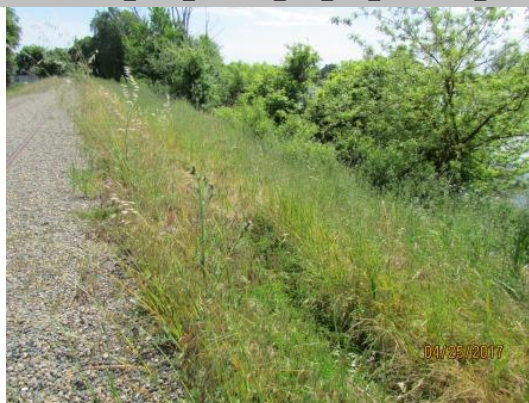
Photo 1 of 1 : SP\_2017\_MA0009\_201\_291\_20170426\_00508.jpg

LM Start	8.61	Rating **	U	Issue No.	291
LM End	9.56	Issue Type +	Ma	Location *	WS
Category	Earthen Levee			GPS Latitude/Longitude	
				Start	End
Item	Vegetation			38.471839 °	38.458519 °
				-121.504962 °	-121.501481 °
DWR ID	DWR_MA0009_01_s_2017_291				
Comment Code					
V1 : Control annual grass and weeds on the levee slopes and easements.					
Inspector Comment

View of tall vegetation on waterside levee slope, blocking visibility. Spring 2017.

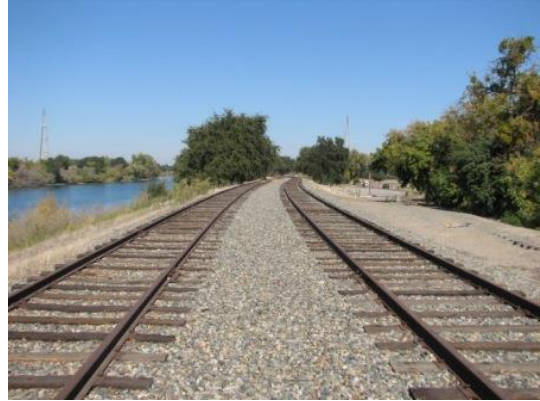
Photo 1 of 2 : SP\_2017\_MA0009\_201\_166\_20170320\_00130.jpg

LM Start	8.76	Rating **	M	Issue No.	166
LM End	10.52	Issue Type +	En	Location *	CR
Category	Earthen Levee			GPS Latitude/Longitude	
				Start	End
Item	Encroachments			38.469929 °	38.444723 °
				-121.503668 °	-121.500283 °
DWR ID	DWR_MA0009_01_s_2012_166				
Comment Code					
EQ : Equipment					
Inspector Comment					
Encroachment is railroad tracks (equipment), access is very limited, no patrol access, vegetation maint. is difficult. Tracks end at Cliff's Marina where Highway 160 crosses tracks, LM 9.36-9.80 is the town of Freeport with many encroachments.

Railroad tracks are on the crown preventing ability to patrol during flood season. Fall 2013

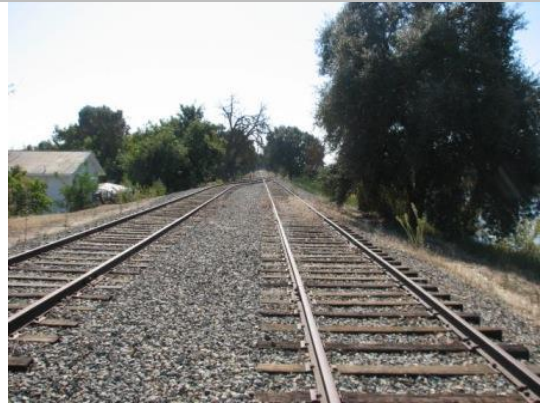
Photo 2 of 2 : SP\_2017\_MA0009\_201\_166\_20170320\_00131.jpg

Looking downstream towards Freeport. Fall 2013

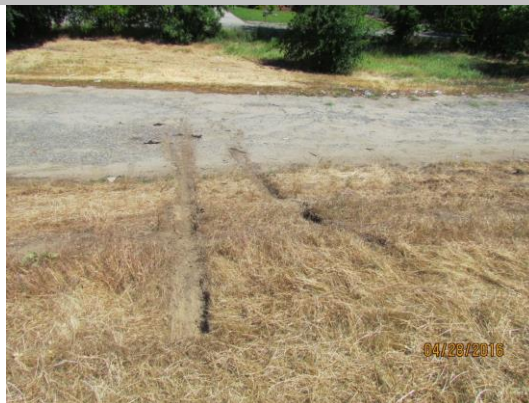
Photo 1 of 2 : SP\_2017\_MA0009\_201\_378\_20170320\_00291.jpg

LM Start	9.17	Rating **	M	Issue No.	378
LM End	9.17	Issue Type +	Ma	Location *	LS
Category	Earthen Levee			GPS Latitude/Longitude	
				Start	End
Item	Slope Stability			38.463960 °	38.463960 °
				-121.502940 °	-121.502940 °
DWR ID	DWR_MA0009_01_s_2016_378				
Comment Code					
S3 : Repair the levee slope damaged by vehicle traffic and prevent access where possible.					
Inspector Comment

Slope stability is on the landward side of the levee. Spring 2016.

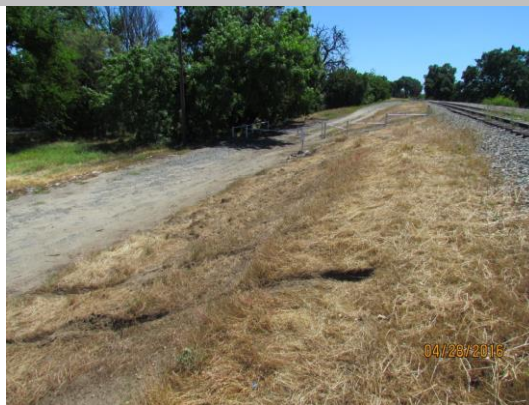
Photo 2 of 2 : SP\_2017\_MA0009\_201\_378\_20170320\_00292.jpg

Perspective view of the slope stability looking downstream. Spring 2016.

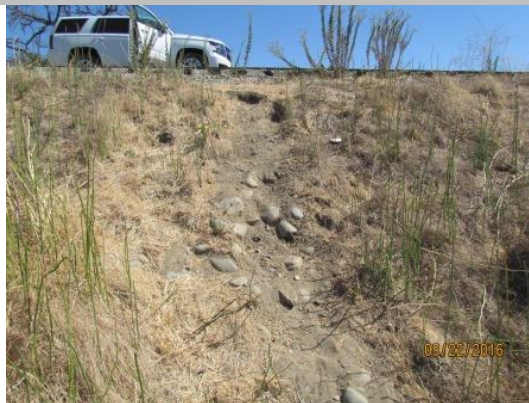
Photo 1 of 1 : SP\_2017\_MA0009\_201\_253\_20170320\_00197.jpg

LM Start	9.22	Rating **	M	Issue No.	253
LM End	9.22	Issue Type +	Ma	Location *	WS
Category	Earthen Levee			GPS Latitude/Longitude	
				Start	End
Item	Slope Stability			38.463301 °	38.463301 °
				-121.502904 °	-121.502904 °
DWR ID	DWR_MA0009_01_f_2016_253				
Comment Code					
S2 : Repair the levee slope damaged by foot traffic and prevent access where possible.					
Inspector Comment

View of a footpath on LS slope causing slope stability issue. Fall 2016.

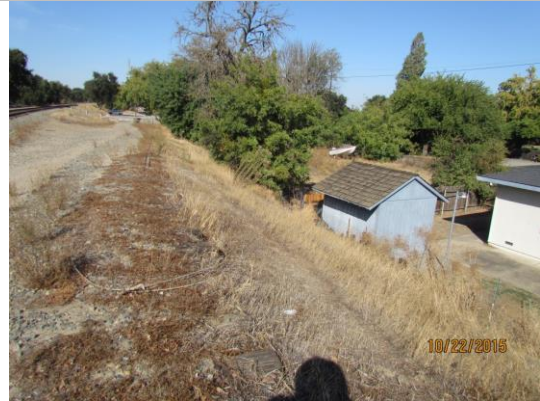
Photo 1 of 1 : SP\_2017\_MA0009\_201\_168\_20170320\_00132.jpg

LM Start	9.23	Rating **	M	Issue No.	168
LM End	9.23	Issue Type +	En	Location *	LS
Category	Earthen Levee			GPS Latitude/Longitude	
				Start	End
Item	Encroachments			38.463138 °	38.463138 °
				-121.502788 °	-121.502788 °
DWR ID	DWR_MA0009_01_s_2012_168				
Comment Code					
BU : Building					
Inspector Comment

View of the building at the toe of the landward side of the levee looking upstream. Fall 2015.

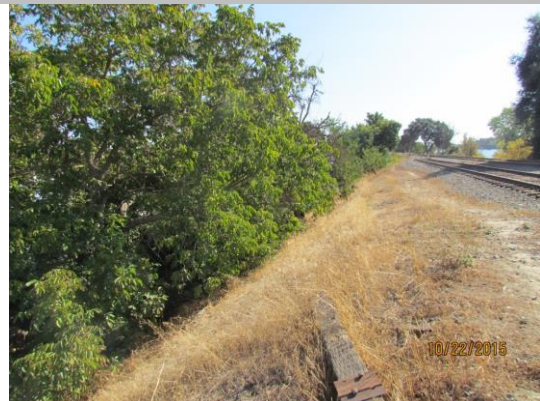
Photo 1 of 1 : SP\_2017\_MA0009\_201\_349\_20170320\_00265.jpg

LM Start	9.24	Rating **	M	Issue No.	349
LM End	9.24	Issue Type +	En	Location *	LS
Category	Earthen Levee			GPS Latitude/Longitude	
				Start	End
Item	Vegetation			38.462957 °	38.462957 °
				-121.502760 °	-121.502760 °
DWR ID	DWR_MA0009_01_f_2015_349				
Comment Code					
V6 : Landscaping					
Inspector Comment					
Tree is landscaped by the property owner. Visibility obstruction of levee slopes is not fully blocked.

View of the trees on the landward side of the levee looking downstream. Fall 2015.

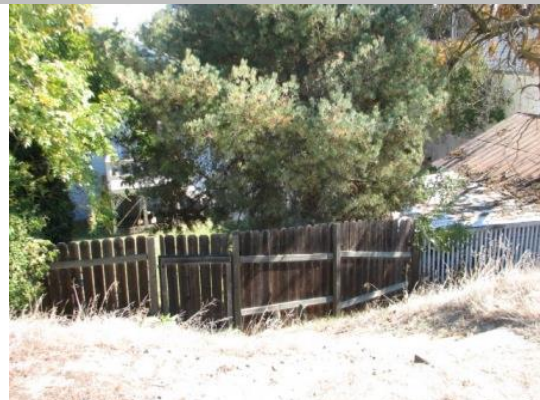
Photo 1 of 2 : SP\_2017\_MA0009\_201\_169\_20170320\_00133.jpg

LM Start	9.25	Rating **	M	Issue No.	169
LM End	9.25	Issue Type +	En	Location *	LS
Category	Earthen Levee			GPS Latitude/Longitude	
				Start	End
Item	Encroachments			38.462900 °	38.462900 °
				-121.502762 °	-121.502762 °
DWR ID	DWR_MA0009_01_s_2012_169				
Comment Code					
FE : Fence					
Inspector Comment

A solid wooden fence and building within the easement. Fall 2013

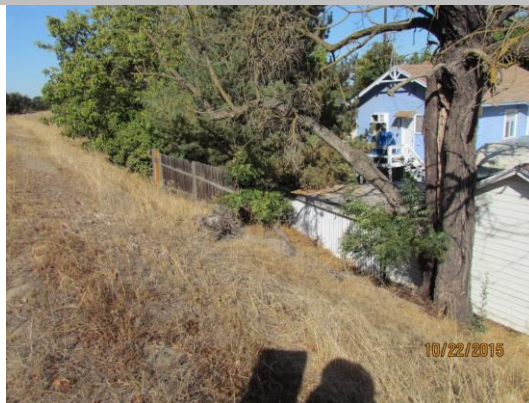
Photo 2 of 2 : SP\_2017\_MA0009\_201\_169\_20170320\_00134.jpg

View of the wooden fence and building on the landward side of the levee looking upstream. Fall 2015.

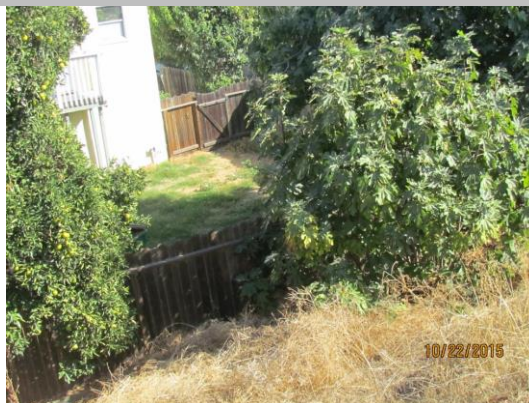
Photo 1 of 1 : SP\_2017\_MA0009\_201\_331\_20170320\_00249.jpg

LM Start	9.25	Rating **	M	Issue No.	331
LM End	9.25	Issue Type +	En	Location *	LS
Category	Earthen Levee			GPS Latitude/Longitude	
				Start	End
Item	Encroachments			38.462802 °	38.462802 °
				-121.502728 °	-121.502728 °
DWR ID	DWR_MA0009_01_f_2013_331				
Comment Code					
FE : Fence					
Inspector Comment

View of the fence and landscape at the toe of the levee on the landward side of the levee. Fall 2015.

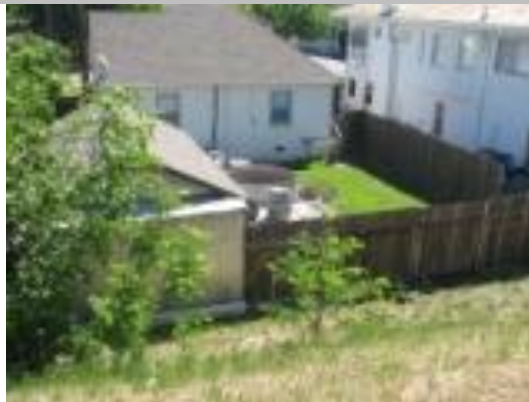
Photo 1 of 2 : SP\_2017\_MA0009\_201\_170\_20170320\_00135.jpg

LM Start	9.26	Rating **	M	Issue No.	170
LM End	9.26	Issue Type +	En	Location *	LS
Category	Earthen Levee			GPS Latitude/Longitude	
				Start	End
Item	Encroachments			38.462653 °	38.462653 °
				-121.502670 °	-121.502670 °
DWR ID	DWR_MA0009_01_s_2012_170				
Comment Code					
BU : Building					
Inspector Comment

A building at the toe. Spring 2013

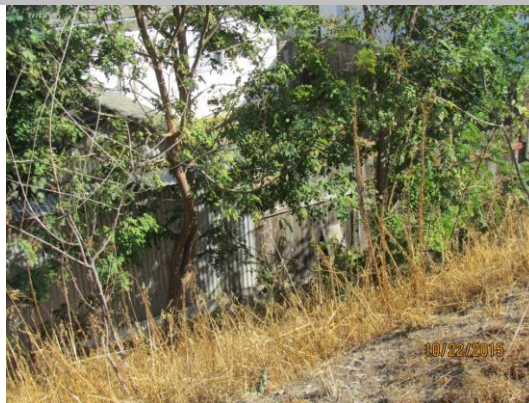
Photo 2 of 2 : SP\_2017\_MA0009\_201\_170\_20170320\_00136.jpg

Trees have grown and blocked the view of the building at the toe of the levee on the landward side. Fall 2015.

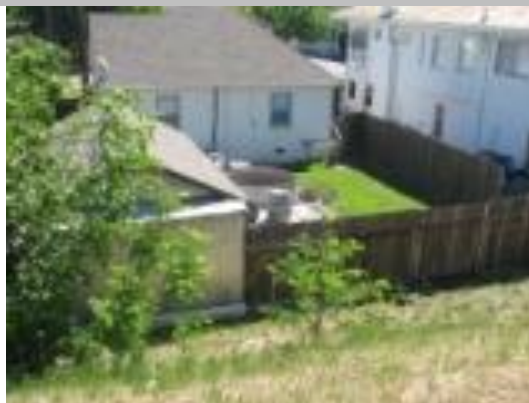
Photo 1 of 2 : SP\_2017\_MA0009\_201\_171\_20170320\_00137.jpg

LM Start	9.26	Rating **	M	Issue No.	171
LM End	9.26	Issue Type +	En	Location *	LS
Category	Earthen Levee			GPS Latitude/Longitude	
				Start	End
Item	Encroachments			38.462653 °	38.462653 °
				-121.502670 °	-121.502670 °
DWR ID	DWR_MA0009_01_s_2012_171				
Comment Code					
FE : Fence					
Inspector Comment

A fence along the toe. Spring 2013

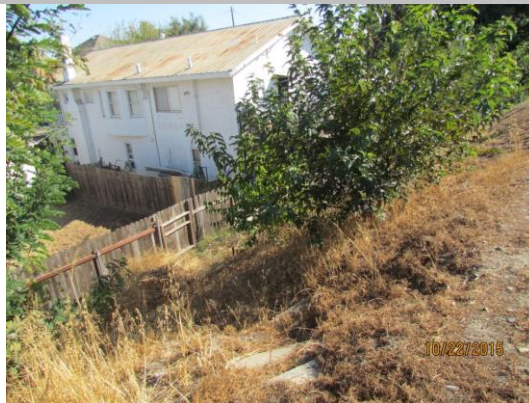
Photo 2 of 2 : SP\_2017\_MA0009\_201\_171\_20170320\_00138.jpg

View of the fence at the toe of the levee on the landward side of the levee. Fall 2015.

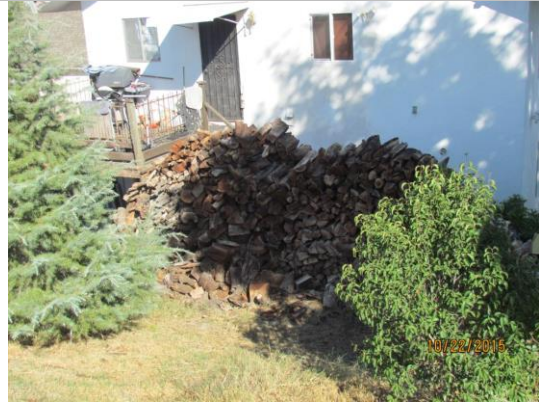
Photo 1 of 1 : SP\_2017\_MA0009\_201\_173\_20170320\_00140.jpg

LM Start	9.28	Rating **	M	Issue No.	173
LM End	9.28	Issue Type +	En	Location *	LS
Category	Earthen Levee			GPS Latitude/Longitude	
				Start	End
Item	Encroachments			38.462458 °	38.462458 °
				-121.502613 °	-121.502613 °
DWR ID	DWR_MA0009_01_f_2013_173				
Comment Code					
FW : Firewood					
Inspector Comment

Firewood is stacked along the toe of the levee on the landward side. Fall 2015.

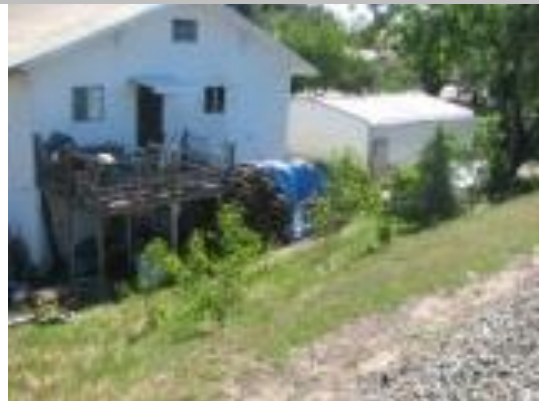
Photo 1 of 1 : SP\_2017\_MA0009\_201\_172\_20170320\_00139.jpg

LM Start	9.28	Rating **	M	Issue No.	172
LM End	9.28	Issue Type +	En	Location *	LS
Category	Earthen Levee			GPS Latitude/Longitude	
				Start	End
Item	Encroachments			38.462452 °	38.462452 °
				-121.502617 °	-121.502617 °
DWR ID	DWR_MA0009_01_s_2012_172				
Comment Code					
BU : Building					
Inspector Comment

The home and other encroachments along the toe. Spring 2013

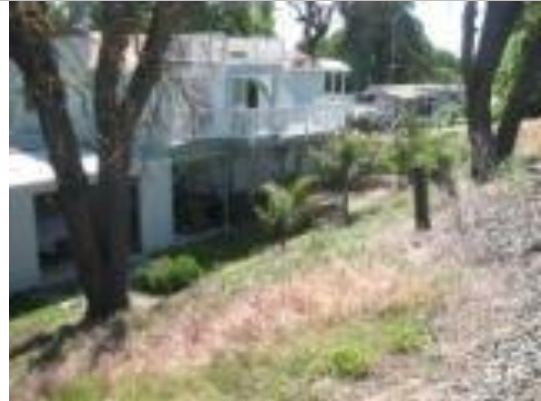
Photo 1 of 1 : SP\_2017\_MA0009\_201\_174\_20170320\_00141.jpg

LM Start	9.31	Rating **	M	Issue No.	174
LM End	9.31	Issue Type +	En	Location *	LS
Category	Earthen Levee			GPS Latitude/Longitude	
				Start	End
Item	Encroachments			38.462040 °	38.462040 °
				-121.502557 °	-121.502557 °
DWR ID	DWR_MA0009_01_s_2012_174				
Comment Code					
BU : Building					
Inspector Comment

A home is within the easement of the levee. Spring 2013

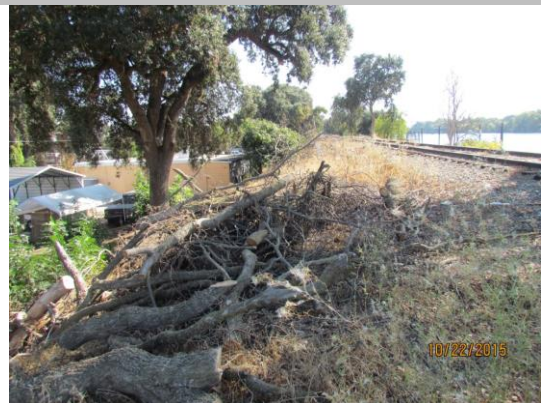
Photo 1 of 1 : SP\_2017\_MA0009\_201\_352\_20170320\_00267.jpg

LM Start	9.33	Rating **	M	Issue No.	352
LM End	9.33	Issue Type +	Ma	Location *	LS
Category	Earthen Levee			GPS Latitude/Longitude	
				Start	End
Item	Encroachments			38.461690 °	38.461690 °
				-121.502447 °	-121.502447 °
DWR ID	DWR_MA0009_01_f_2015_352				
Comment Code					
PR : Prunings					
Inspector Comment

View of pruning pile on the landward side of the levee looking downstream. Fall 2015.

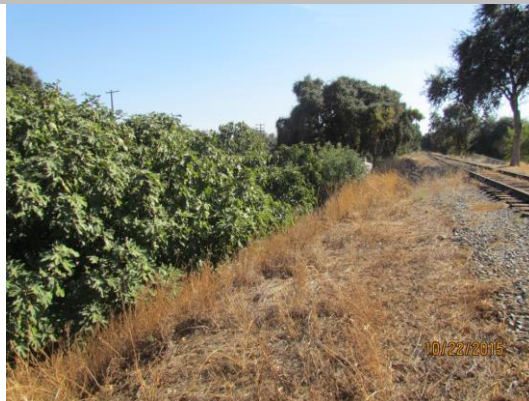
Photo 1 of 1 : SP\_2017\_MA0009\_201\_177\_20170320\_00144.jpg

LM Start	9.36	Rating **	M	Issue No.	177
LM End	9.36	Issue Type +	En	Location *	LS
Category	Earthen Levee			GPS Latitude/Longitude	
				Start	End
Item	Vegetation			38.461343 °	38.461343 °
				-121.502345 °	-121.502345 °
DWR ID	DWR_MA0009_01_s_2012_177				
Comment Code					
V6 : Landscaping					
Inspector Comment

View of the trees on the landward side of the levee looking downstream. Fall 2015.

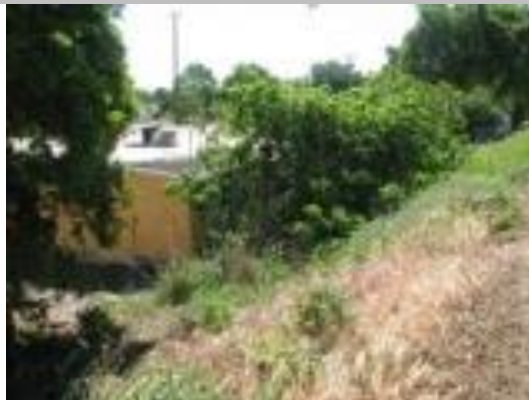
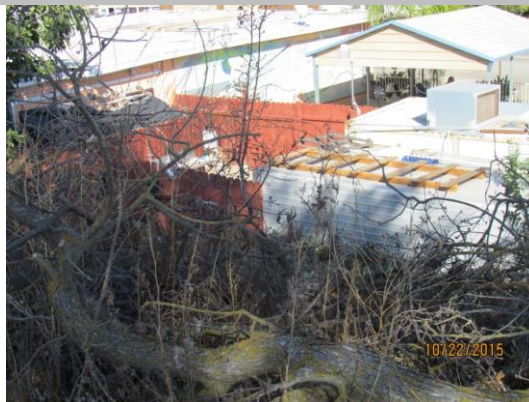
Photo 1 of 2 : SP\_2017\_MA0009\_201\_176\_20170320\_00142.jpg

LM Start	9.36	Rating **	M	Issue No.	176
LM End	9.36	Issue Type +	En	Location *	LS
Category	Earthen Levee			GPS Latitude/Longitude	
				Start	End
Item	Encroachments			38.461338 °	38.461338 °
				-121.502352 °	-121.502352 °
DWR ID	DWR_MA0009_01_s_2012_176				
Comment Code					
BU : Building					
Inspector Comment

The building is at the toe of the levee. Spring 2013

View of the storage shed at the toe of the levee on the landward side. Fall 2015.

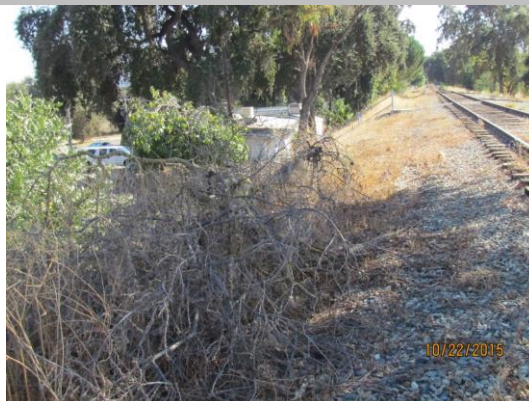
Photo 1 of 1 : SP\_2017\_MA0009\_201\_353\_20170320\_00268.jpg

LM Start	9.37	Rating **	M	Issue No.	353
LM End	9.37	Issue Type +	Ma	Location *	LS
Category	Earthen Levee			GPS Latitude/Longitude	
				Start	End
Item	Encroachments			38.461202 °	38.461202 °
				-121.502283 °	-121.502283 °
DWR ID	DWR_MA0009_01_f_2015_353				
Comment Code					
PR : Prunings					
Inspector Comment

View of the pruning pile on the landward side of the levee looking downstream. Fall 2015.

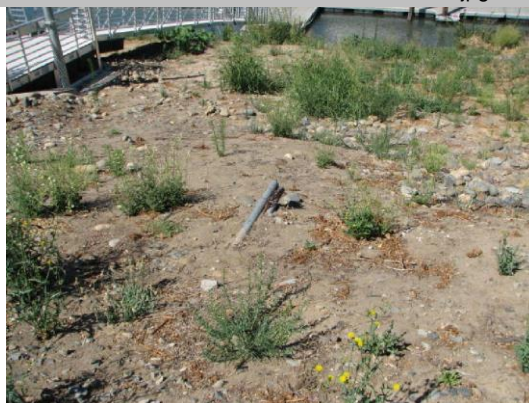
Photo 1 of 1 : UCIP\_SP\_2017\_5903\_8967.jpg

LM Start	9.39	Rating **	M	Issue No.	1795
LM End	9.39	Issue Type +	En	Location *	LS
Category	Supplemental			GPS Latitude/Longitude	
				Start	End
Item	DWR UCIP Field Study			38.460920 °	38.460920 °
				-121.502220 °	-121.502220 °
DWR ID					
Comment Code					
Inspector Comment					
FS_ID:5903 DS_ID:18946 EP_NO: N/A Repair Type: Non-Urgent Crossing Status: Found UCIP Comments: No permit identified for this crossing. Pipes should be removed or filled with grout. FIELD_STRUCT_DESC: 1 of 2: 2-inch steel pipe 1.5-feet below the crown open on both ends. FS Date: 6/21/2012 2:57:40 PM

View of pipe from WS shoulder looking towards river.

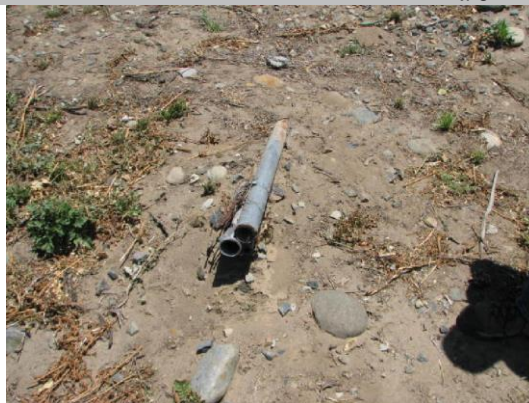
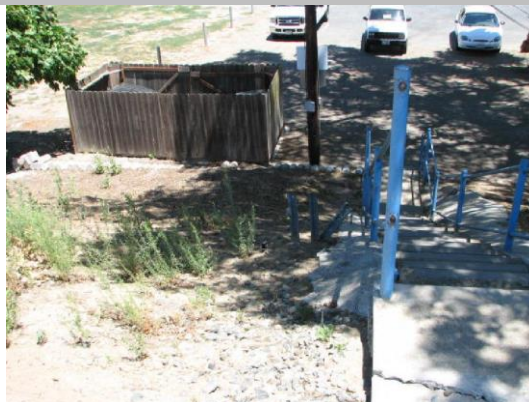
Photo 1 of 2 : UCIP\_SP\_2017\_5904\_8969.jpg

LM Start	9.39	Rating **	M	Issue No.	1796
LM End	9.39	Issue Type +	En	Location *	LS
Category	Supplemental			GPS Latitude/Longitude	
				Start	End
Item	DWR UCIP Field Study			38.460920 °	38.460920 °
				-121.502220 °	-121.502220 °
DWR ID					
Comment Code					
Inspector Comment					
FS_ID:5904 DS_ID:18947 EP_NO: N/A Repair Type: Non-Urgent Crossing Status: Found UCIP Comments: No permit identified for this crossing. Pipe should be removed or grouted in place. FIELD_STRUCT_DESC: 2 of 2: 2-inch galvanized steel pipe 1.5-feet below the crown open on both ends. FS Date: 6/21/2012

Pipe on WS shoulder.

Pipe buried 3-feet upstream from top of stairs on LS slope.

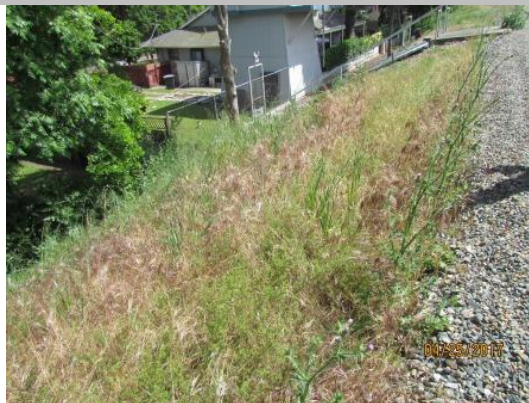
Photo 1 of 1 : SP\_2017\_MA0009\_201\_298\_20170426\_00509.jpg

LM Start	9.39	Rating **	U	Issue No.	298
LM End	9.56	Issue Type +	Ma	Location *	LS
Category	Earthen Levee			GPS Latitude/Longitude	
				Start	End
Item	Vegetation			38.460892 °	38.458519 °
				-121.502219 °	-121.501481 °
DWR ID	DWR_MA0009_01_s_2017_298				
Comment Code					
V1 : Control annual grass and weeds on the levee slopes and easements.					
Inspector Comment

View of tall vegetation on landside levee slope, blocking visibility. Spring 2017.

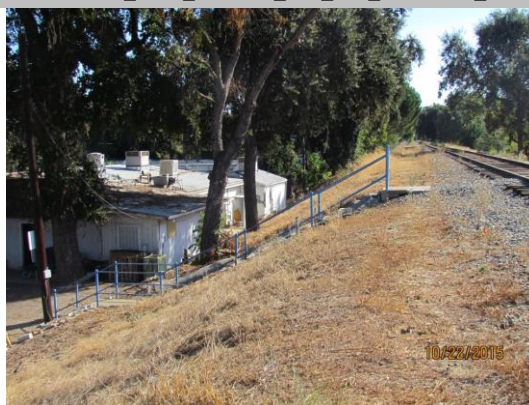
Photo 1 of 1 : SP\_2017\_MA0009\_201\_178\_20170320\_00145.jpg

LM Start	9.40	Rating **	M	Issue No.	178
LM End	9.40	Issue Type +	En	Location *	LS
Category	Earthen Levee			GPS Latitude/Longitude	
				Start	End
Item	Encroachments			38.460772 °	38.460772 °
				-121.502170 °	-121.502170 °
DWR ID	DWR_MA0009_01_s_2012_178				
Comment Code					
BU : Building					
Inspector Comment

View of the building within the easement on the landward side of the levee looking downstream. Fall 2015.

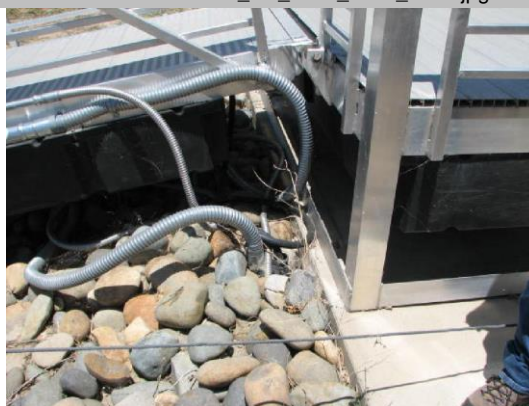
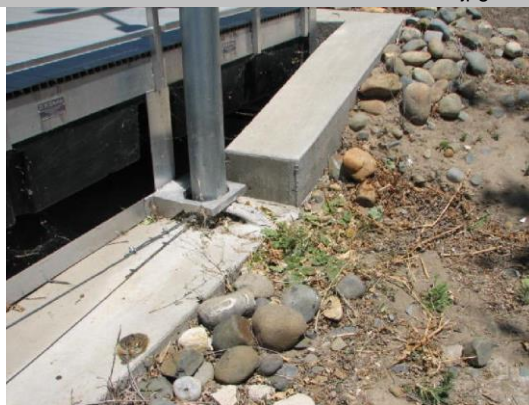
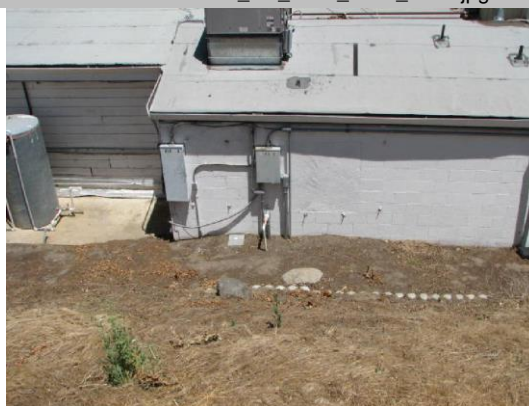
Photo 1 of 3 : UCIP\_SP\_2017\_5905\_8972.jpg

LM Start	9.40	Rating **	M	Issue No.	1797
LM End	9.40	Issue Type +	En	Location *	LS
Category	Supplemental			GPS Latitude/Longitude	
				Start	End
Item	DWR UCIP Field Study			38.460670 °	38.460670 °
				-121.502140 °	-121.502140 °
DWR ID					
Comment Code					
Inspector Comment					
FS_ID:5905 DS_ID:18948 EP_NO: N/A Repair Type: Non-Urgent Crossing Status: Found UCIP Comments: No permit identified for this crossing. Likely that this is a service line that provides power for the boat dock. FIELD_STRUCT_DESC: Christie box on WS shoulder. Possibly a utility crossing connecting to electrical panel on building at LS toe. Pipe not visible. FS Date: 6/21/2012 3:04:17 PM

Likely that the pipes at the boat walkway cross at the christie box.

Likely that the pipes at the fuse box on the LS toe building cross at the christie box to serve boat dock.

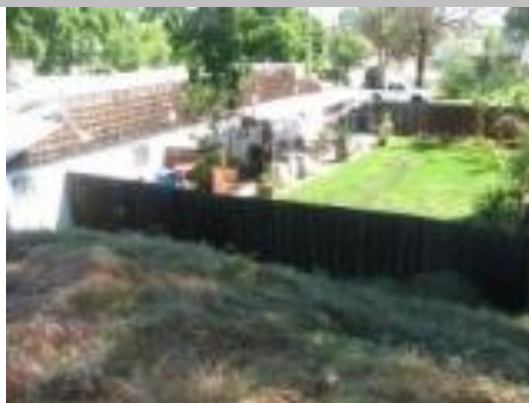
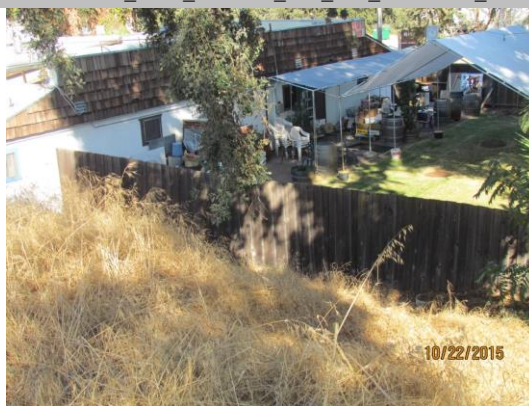
Photo 1 of 2 : SP\_2017\_MA0009\_201\_179\_20170320\_00146.jpg

LM Start	9.41	Rating **	U	Issue No.	179
LM End	9.41	Issue Type +	En	Location *	LS
Category	Earthen Levee			GPS Latitude/Longitude	
				Start	End
Item	Encroachments			38.460573 °	38.460573 °
				-121.502127 °	-121.502127 °
DWR ID	DWR_MA0009_01_s_2012_179				
Comment Code					
FE : Fence					
Inspector Comment

The fence is at the toe of the levee. Spring 2013

View of the fence on the landward side of the levee. Fall 2015.

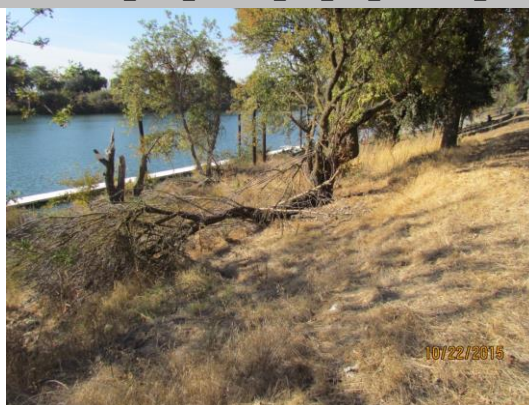
Photo 1 of 1 : SP\_2017\_MA0009\_201\_356\_20170320\_00269.jpg

LM Start	9.43	Rating **	M	Issue No.	356
LM End	9.43	Issue Type +	Ma	Location *	WS
Category	Earthen Levee			GPS Latitude/Longitude	
				Start	End
Item	Encroachments			38.460343 °	38.460343 °
				-121.502102 °	-121.502102 °
DWR ID	DWR_MA0009_01_f_2015_356				
Comment Code					
TR : Tree or limb					
Inspector Comment

View of the fallen tree on the waterward side of the levee looking upstream. Fall 2015.

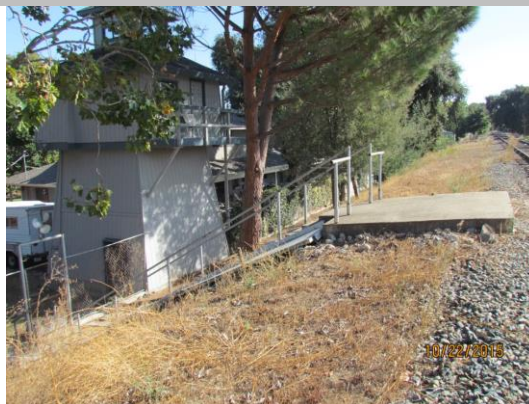
Photo 1 of 1 : SP\_2017\_MA0009\_201\_180\_20170320\_00148.jpg

LM Start	9.44	Rating **	M	Issue No.	180
LM End	9.44	Issue Type +	En	Location *	LS
Category	Earthen Levee			GPS Latitude/Longitude	
				Start	End
Item	Encroachments			38.460210 °	38.460210 °
				-121.502030 °	-121.502030 °
DWR ID	DWR_MA0009_01_s_2012_180				
Comment Code					
BU : Building					
Inspector Comment

View of the building within the easement on the landward side of the levee looking downstream. Fall 2015.

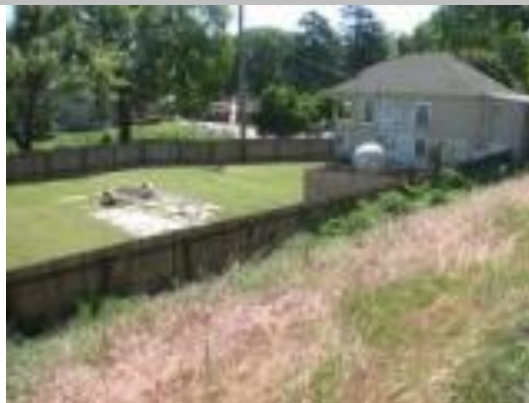
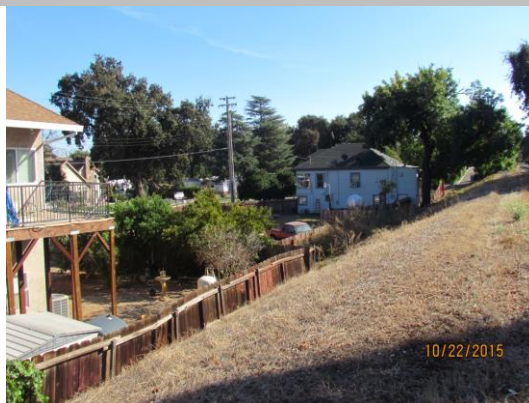
Photo 1 of 2 : SP\_2017\_MA0009\_201\_181\_20170320\_00149.jpg

LM Start	9.48	Rating **	U	Issue No.	181
LM End	9.52	Issue Type +	En	Location *	LS
Category	Earthen Levee			GPS Latitude/Longitude	
				Start	End
Item	Encroachments			38.459665 °	38.458993 °
				-121.501847 °	-121.501642 °
DWR ID	DWR_MA0009_01_s_2012_181				
Comment Code					
FE : Fence					
Inspector Comment

The fence continues along the toe. Spring 2013

View of the fence along the toe of the levee on the landward side looking downstream. Fall 2015.

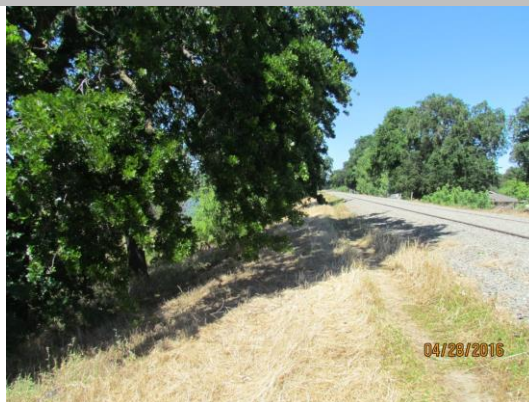
Photo 1 of 1 : SP\_2017\_MA0009\_201\_380\_20170320\_00294.jpg

LM Start	9.50	Rating **	M	Issue No.	380
LM End	9.50	Issue Type +	Ma	Location *	WS
Category	Earthen Levee			GPS Latitude/Longitude	
				Start	End
Item	Trim / Thin Trees			38.459358 °	38.459358 °
				-121.501770 °	-121.501770 °
DWR ID	DWR_MA0009_01_s_2016_380				
Comment Code					
T1 : Trim trees to at least five feet above ground level.					
Inspector Comment

View of the trees on the waterward side of the levee looking upstream. Spring 2016.

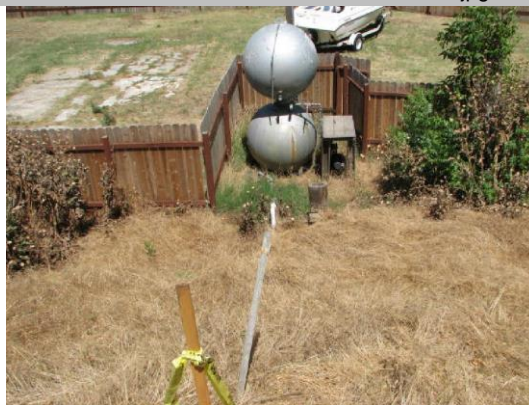
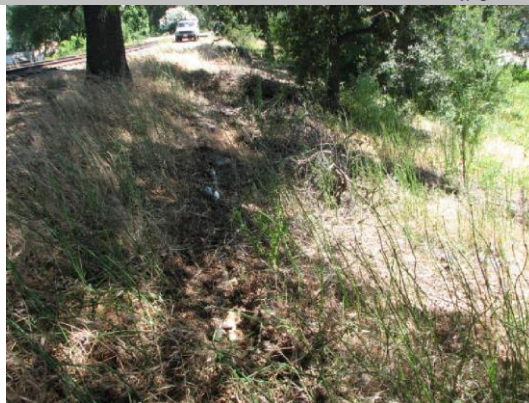
Photo 1 of 2 : UCIP\_SP\_2017\_5907\_8976.jpg

LM Start	9.52	Rating **	M	Issue No.	1798
LM End	9.52	Issue Type +	En	Location *	CR
Category	Supplemental			GPS Latitude/Longitude	
				Start	End
Item	DWR UCIP Field Study			38.459110 °	38.459110 °
				-121.501660 °	-121.501660 °
DWR ID					
Comment Code					
Inspector Comment					
FS_ID:5907					
DS_ID:18952					
EP_NO: N/A					
Repair Type: Non-Urgent					
Crossing Status: Found					
UCIP Comments: No permit identified for this crossing.					
FIELD_STRUCT_DESC: 2-inch PVC waterline through the levee 3-feet below the crown. Pump and tank system on LS toe.					
FS Date: 6/21/2012 3:12:50 PM

Pipe runs down LS slope to tank and pump at LS toe.

Pipe runs downstream parallel to levee crown just under the surface towards marina.

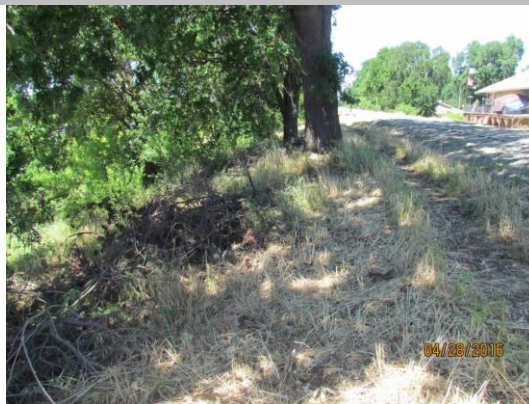
Photo 1 of 1 : SP\_2017\_MA0009\_201\_379\_20170320\_00293.jpg

LM Start	9.53	Rating **	M	Issue No.	379
LM End	9.53	Issue Type +	Ma	Location *	WS
Category	Earthen Levee			GPS Latitude/Longitude	
				Start	End
Item	Encroachments			38.458915 °	38.458915 °
				-121.501655 °	-121.501655 °
DWR ID	DWR_MA0009_01_s_2016_379				
Comment Code					
PR : Prunings					
Inspector Comment

View of the pruning pile on the waterward side of the levee looking upstream. Spring 2016.

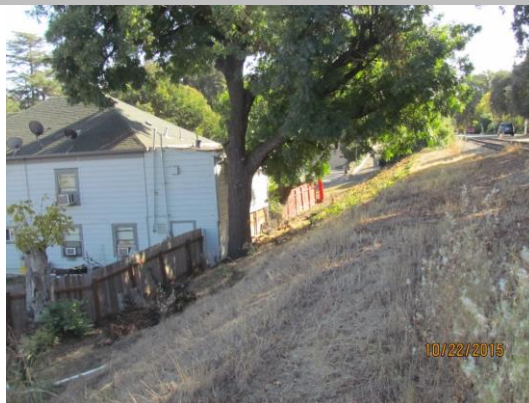
Photo 1 of 1 : SP\_2017\_MA0009\_201\_182\_20170320\_00151.jpg

LM Start	9.53	Rating **	M	Issue No.	182
LM End	9.53	Issue Type +	En	Location *	LS
Category	Earthen Levee			GPS Latitude/Longitude	
				Start	End
Item	Encroachments			38.458878 °	38.458878 °
				-121.501605 °	-121.501605 °
DWR ID	DWR_MA0009_01_s_2012_182				
Comment Code					
BU : Building					
Inspector Comment

View of the building at the toe of the levee on the landward side looking downstream. Fall 2015.

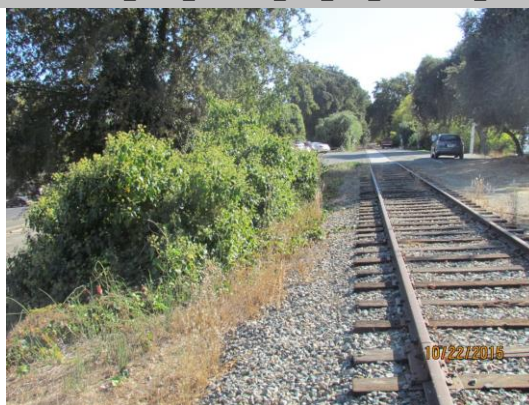
Photo 1 of 1 : SP\_2017\_MA0009\_201\_183\_20170320\_00152.jpg

LM Start	9.56	Rating **	M	Issue No.	183
LM End	9.58	Issue Type +	En	Location *	LS
Category	Earthen Levee			GPS Latitude/Longitude	
				Start	End
Item	Vegetation			38.458450 °	38.458220 °
				-121.501498 °	-121.501397 °
DWR ID	DWR_MA0009_01_s_2012_183				
Comment Code					
V6 : Landscaping					
Inspector Comment

View of the landscaping on the landward side of the levee looking downstream. Fall 2015.
